Minneapolis I-35W Bridge Collapse – Engineering Evaluations and Finite Element Analyses

Carl R. Schultheisz, Alan S. Kushner
National Transportation Safety Board

Abstract: The National Transportation Safety Board (NTSB) investigates accidents to identify the probable cause and to make recommendations that would prevent similar accidents. Following the collapse of the I-35W bridge in Minneapolis on August 1, 2007, the NTSB worked with the Federal Highway Administration, the Minnesota Department of Transportation and other parties with information and expertise, including SIMULIA Central, to determine the circumstances that contributed to the collapse of the bridge, completing the investigation in 15 months. The NTSB concluded that the collapse of the bridge was caused by the inadequate load capacity of gusset plates used to connect the truss members, as a result of an error by the bridge design firm, Sverdrup & Parcel and Associates, Inc. The loading conditions included a combination of (1) substantial increases in the weight of the bridge caused by previous bridge modifications, and (2) the traffic and concentrated construction loads on the bridge on the day of the collapse. Evid

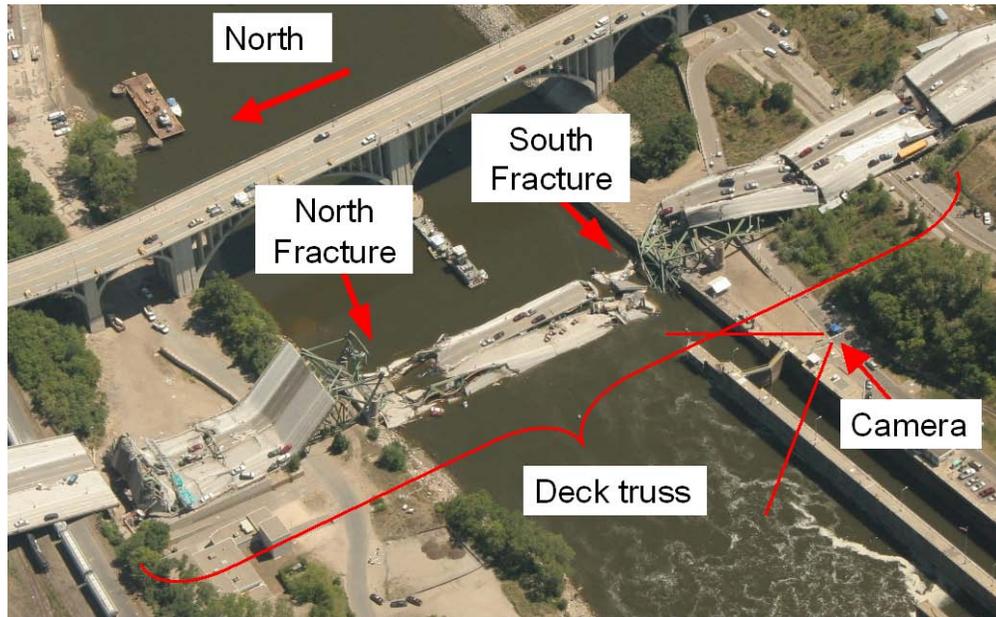
portion of the bridge collapsed, along with adjacent sections of the approach spans that were supported by the deck truss. See Figure 1. A total of 190 people were confirmed to have been on or near the bridge when the collapse occurred; 13 people died, and 145 people were injured. There were 111 vehicles on the portion of the bridge that collapsed, with 17 recovered from the water.

Figure 1. The collapsed deck truss portion of the I-35W bridge.

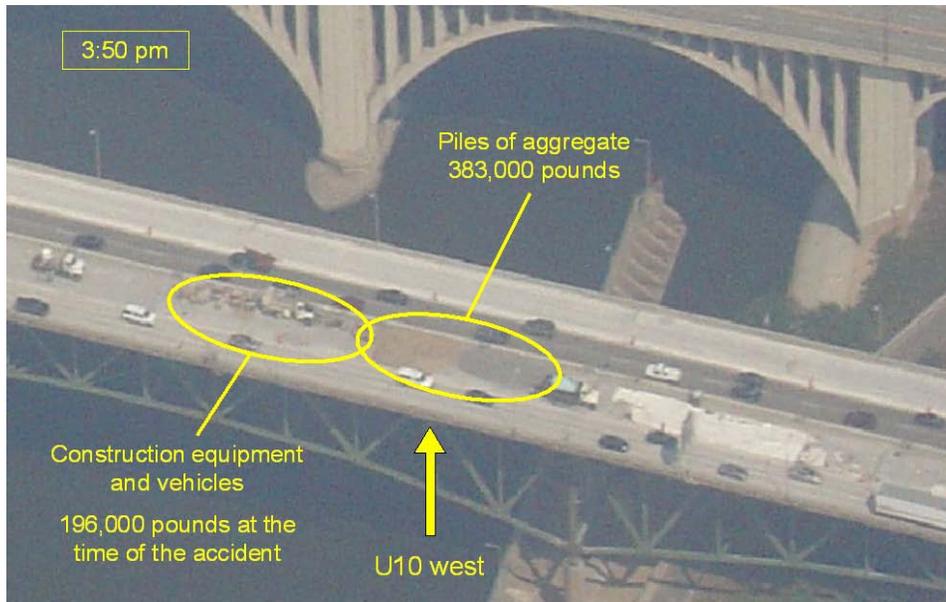
On the day of the collapse, aggregates and equipment for the repaving project were staged on the center span of the deck truss portion of the bridge. The construction aggregates were distributed in eight adjacent piles (four truckloads of sand and four of gravel) placed along the median in the leftmost southbound lane just north of pier 6. Along with the aggregates in this area were a water tanker truck with 3,000 gallons of water, a cement tanker, a concrete mixer, one small loader/excavator, and four self-propelled walk-behind or ride-along buggies for moving smaller amounts of materials. The documented delivered weights for the aggregates staged on the bridge were 184,380 pounds of gravel and 198,820 pounds of sand. The estimated weight of the parked construction vehicles, equipment, and personnel in this area was 196,000 pounds. Figure 2 is a photograph showing the sand and gravel piles about 2 hours before the collapse.

Figure 2. The locations and weights of the construction materials and vehicles.

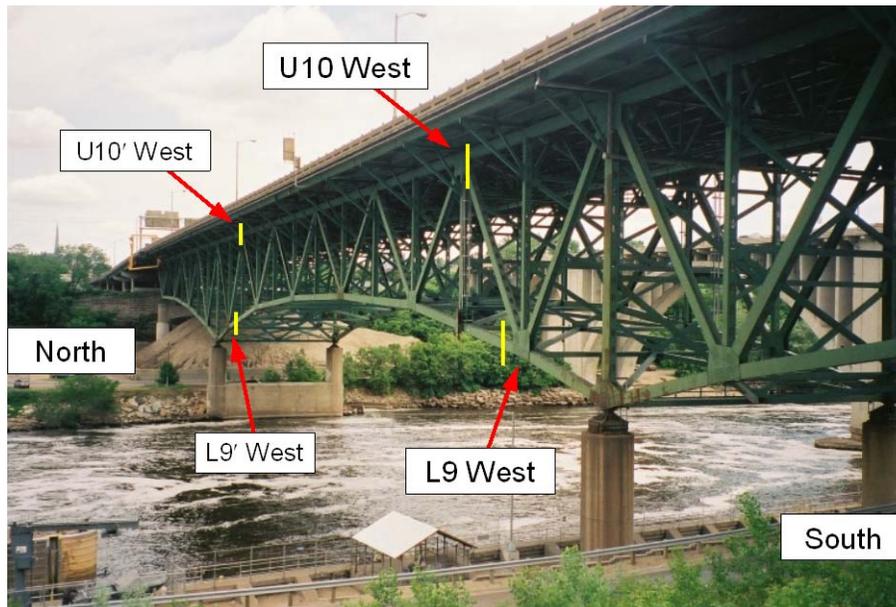
The deck truss portion of the bridge separated into three sections. The separations occurred at symmetric positions north and south of the center of the bridge, through both the east and west trusses. Fractures through the U10 and U10' gusset plates severed the connections of the upper chords and the connections between the L9/U10 and L9'/U10' compression diagonals and the central section of the bridge. The lower chords were severed by fractures through the L9/L10 and L9'/L10' members adjacent to the gusset plates at the L9 and L9' nodes. The positions of the fractures are indicated in Figure 1 and in a pre-collapse photograph in Figure 3.

Figure 3. Identifying the L9, L9', U10 and U10' nodes on the west main truss. Short yellow lines mark the fractures that separated the west truss.

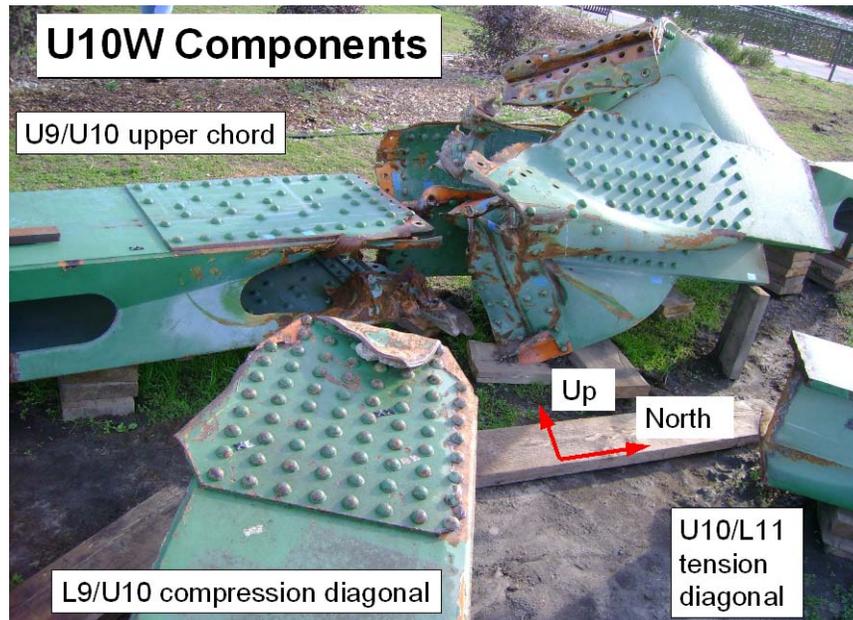
The deformation and fractures in the U10 gusset plates surrounding the upper ends of the L9/U10 compression diagonals were consistent with the in-plane loads expected in the truss. See Figures 4 and 5. The damage was consistent with bending and tearing of the gusset plates under compression above the ends of the L9/U10 diagonals, with fractures under tension through the bottom rows of rivets on the L9/U10 diagonals adjacent to the verticals. These fractures in the U10 gusset plates left a portion of each gusset plate attached to the upper ends of the separated diagonals L9/U10, with a V-shaped piece of each gusset plate extending beyond the ends of the diagonals. On both the east and west diagonals, these V-shaped pieces were bent toward the east, indicating that the upper ends of the diagonals shifted laterally to the west as the gusset plates deformed and fractured, and the east side plates of the diagonals penetrated through the interior structure of the nodes.

Figure 4. Reconstructed U10W components, looking at the east gusset plate.

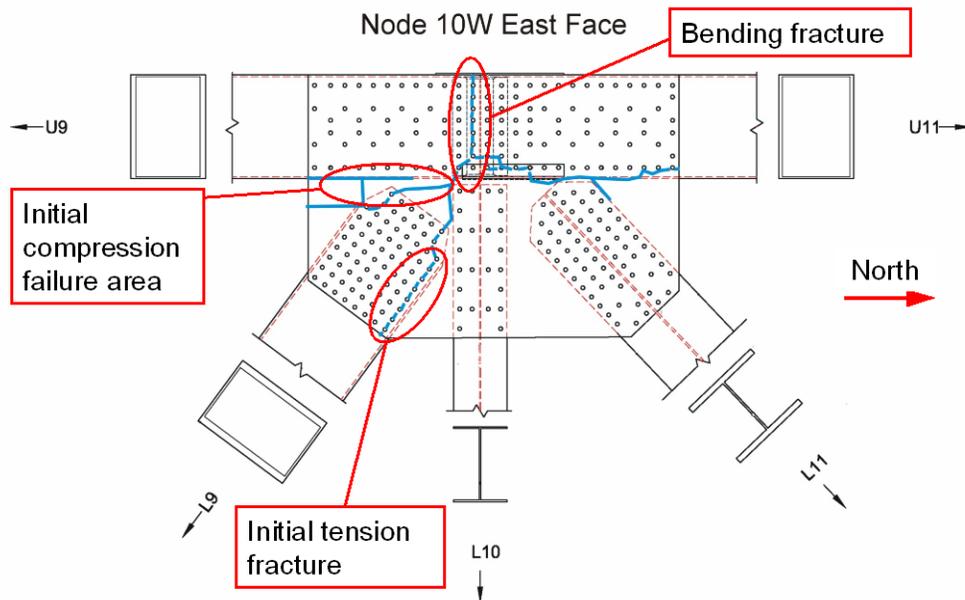
Figure 5. A map of the fractures in the east gusset plate of the U10W node.

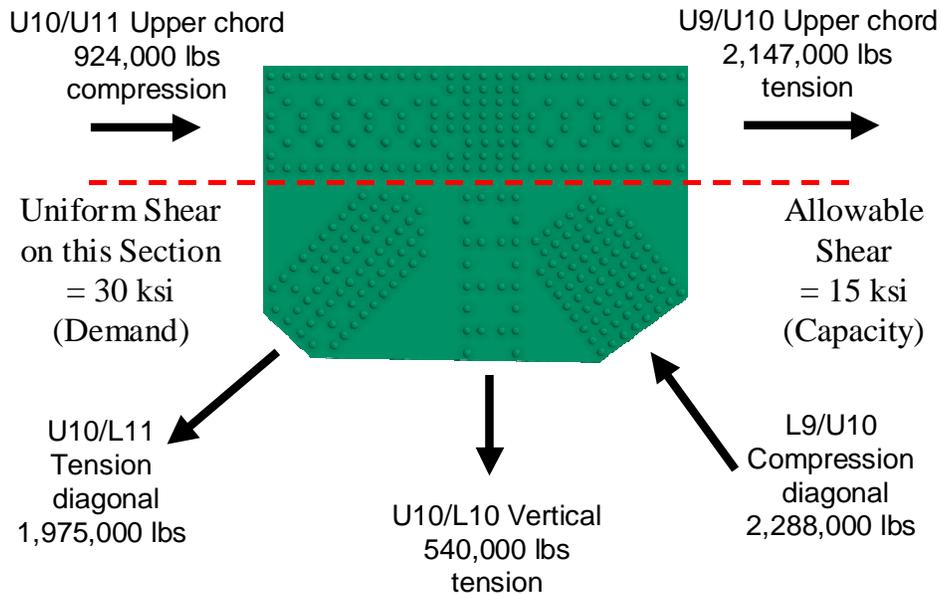
Using a basic design methodology consistent with that used by Sverdrup & Parcel to design the gusset plates for the floor trusses, FHWA engineers calculated the stresses on the main truss gusset plates that would be generated by the design loads (demand) in the members secured by the gusset plates [Holt 2008]. Comparing these stresses to the allowable stresses (capacity) in the AA-SHO specifications resulted in demand-to-capacity (D/C) ratios that illustrate the expected performance of the gusset plates. A D/C ratio of slightly greater than 1 (demand exceeds design capacity) are sometimes acceptable based on the professional judgment of an engineer. A D/C ratio significantly greater than 1 likely indicates a design error.

Figure 6. Calculating the gusset plate shear stress on a horizontal section from the design loads indicated.

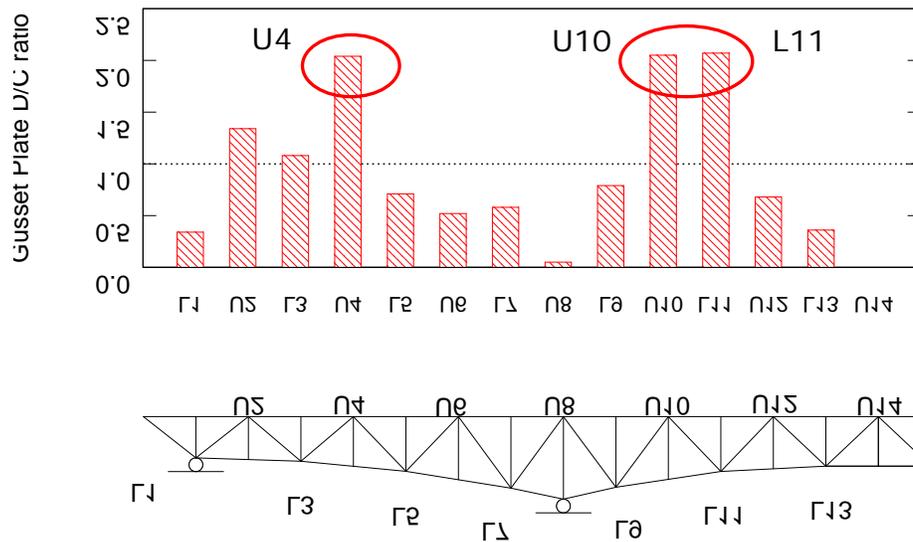
The evaluations considered stresses on two critical sections in each gusset plate - one horizontal section near the center of the gusset along the edge of the chord members, as shown in Figure 6, and one vertical section adjacent to the vertical member of the node. Results of the horizontal section calculations are provided in Figure 7, showing that the gusset plates at the U4, U10, and L11 nodes had D/C ratios for shear that exceeded 2. In addition, the gusset plates at two other nodes had D/C ratios slightly over 1 for shear. The analysis indicates that the gusset plates at the U4, U10, and L11 nodes were only half as thick as necessary to meet the design requirements.

Figure 7. D/C ratios for the gusset plates along the truss, shown with a sketch of the south end of the bridge.

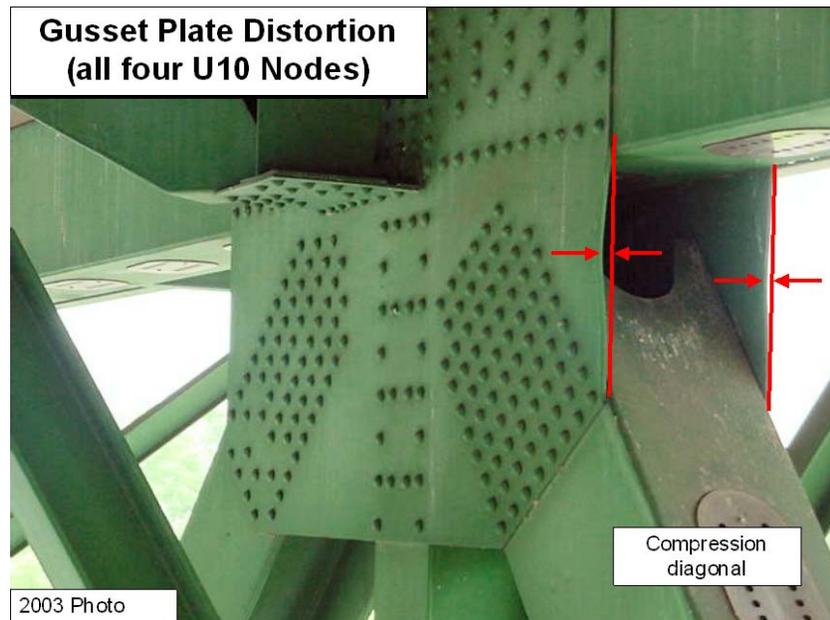
Photographs from 1999 and 2003 were used by NTSB to estimate the magnitude and direction of bowing distortion in the U10W and U10E gusset plates for input to the models [NTSB 2008f]. See Figure 10. The bowing distortion was included as an initial imperfection. The estimate of the maximum bowing magnitude used for input to the models was 0.60 ± 0.15 inch. To generate bowing consistent with that shown in the photographs, it was necessary to use an initial maximum deflec-

tion of 0.5 inch in the unloaded model, which increased to 0.6–0.7 inch after application of the original bridge dead load plus the added deck and the modified barriers (the loading condition at the time the bowed gusset plates were photographed).

Figure 10. Gusset plate bowing distortion at one of the U10 nodes.

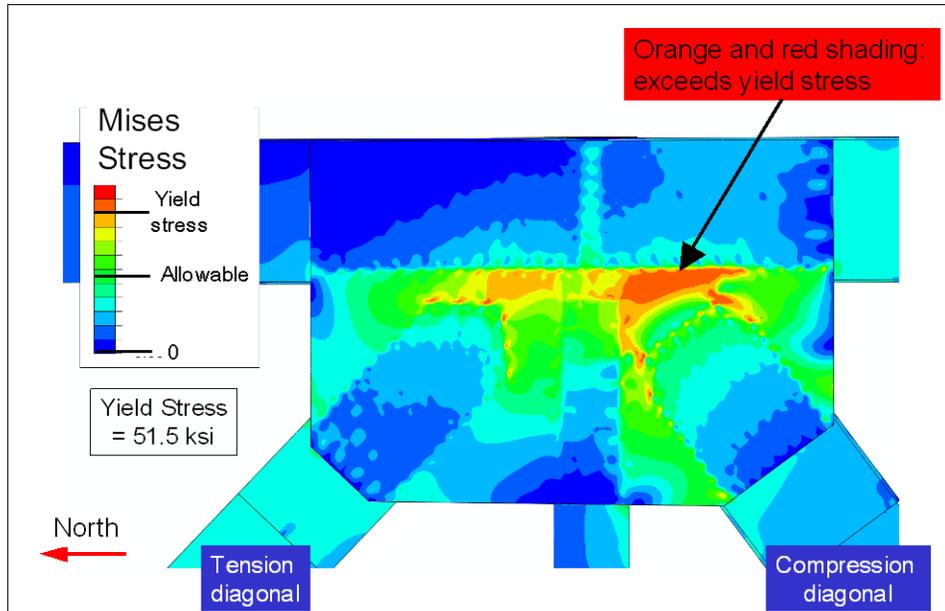
The models showed that the U10 gusset plates were loaded beyond their yield stress under the dead weight of the as-built 1967 bridge (Figure 11). At that stage of loading, the areas of yielding were confined to a small area above the ends of the L9/U10 compression diagonals. As the weight of the bridge was increased by the 1977 and 1998 modifications, the areas above the yield stress expanded around the ends of the L9/U10 compression diagonals, and the areas above the ends of the U10/L11 tension diagonals began to yield as well (Figure 12). Under the added weight of the

Figure 11. Mises stress contours under the dead load of the original 1967 bridge.

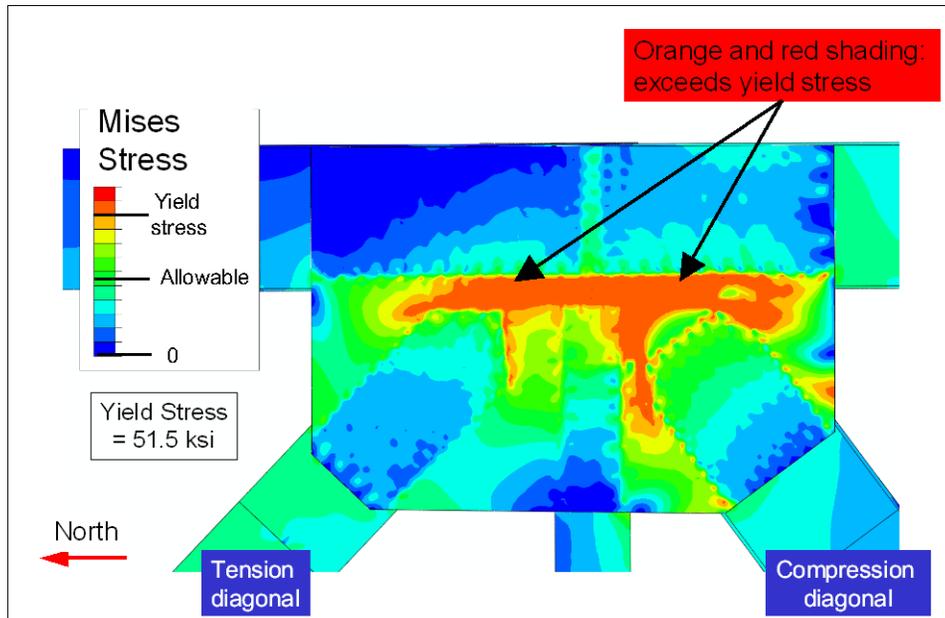
Figure 12. Mises stress contours after the 1977 and 1998 modifications.

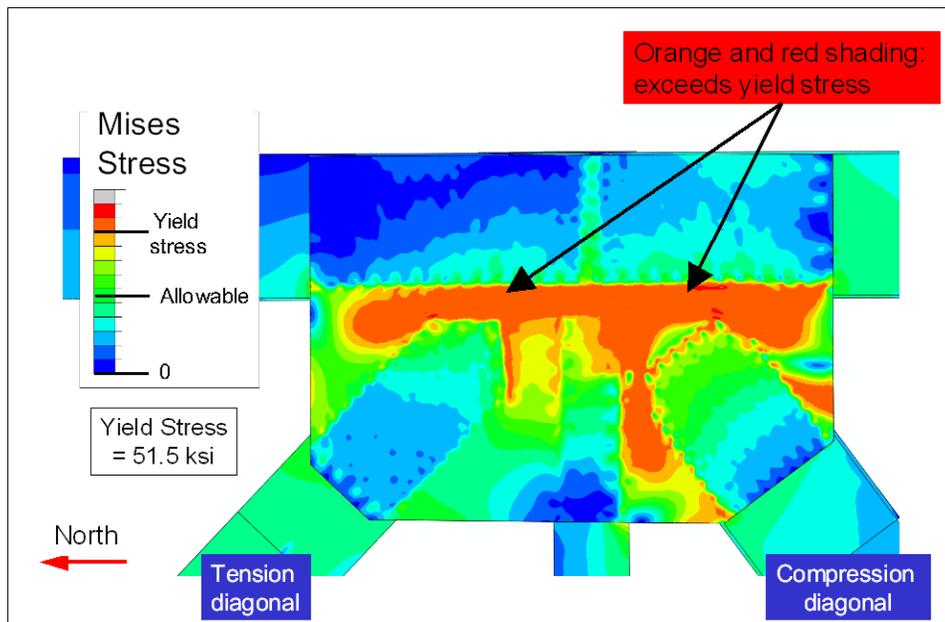
traffic and construction materials and vehicles on the day of the accident, almost all of the U10 gusset plates surrounding the upper end of the L9/U10W compression diagonal were yielding (Figure 13). Because the construction materials were staged on the west side of the bridge, the U10W gusset plates were yielding to a greater extent than those at U10E, with instability therefore occurring first at U10W.

Figure 13. Mises stress contours under the estimated loads on the bridge at the time of the collapse.

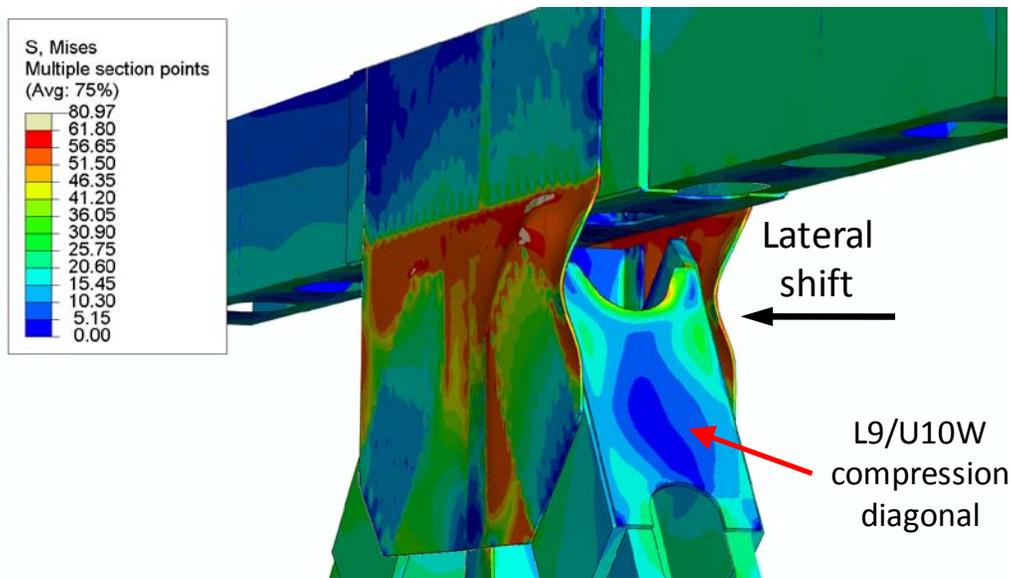
The yielding of the U10W gusset plates surrounding the upper end of the L9/U10W compression diagonal created a plastic hinge in the structure, and the finite element analysis indicated that the collapse initiated by a local bending instability in the U10W gusset plates. This instability allowed for a lateral shift of the upper end of the L9/U10W diagonal, as indicated in Figure 14, removing support from the central portion of the bridge.

Figure 14. Indicating the lateral shift of the L9/U10W diagonal, with Mises stress contours.

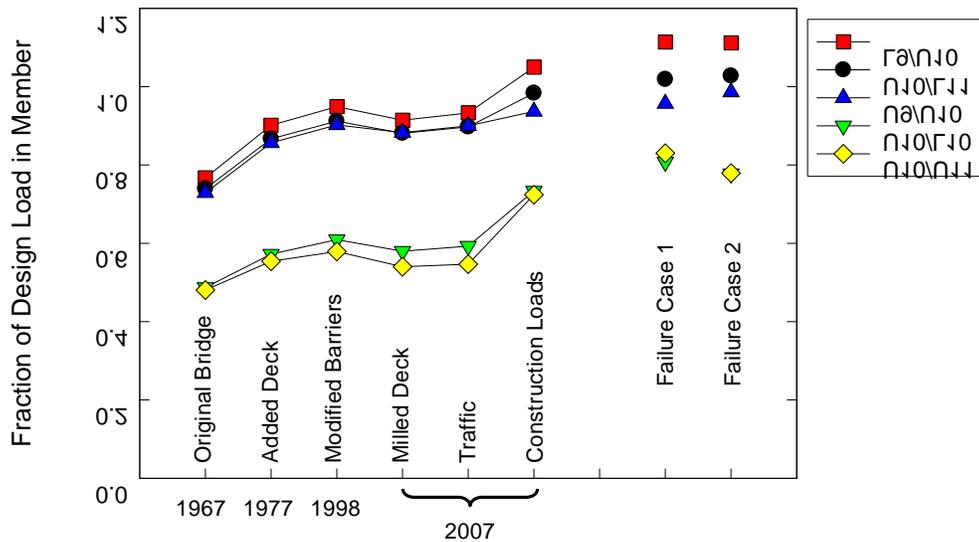
The design loads for the five truss members that joined at U10W are shown in Table 1. The loads in those members over the history of the bridge are shown in Figure 15. The figure shows that the members were at the most about 5 percent above their design loads under the best estimate of the conditions on the bridge at the time of the collapse. The intent of the design methodology should have ensured that, under the design load, the stress in the gusset plates would have been no more than 55 percent of the yield stress. The yielding in the gusset plates under only the dead weight of the original 1967 bridge confirms the inadequate thickness of the gusset plates identified in the FHWA design review.

Figure 15 also shows that the concentration of the construction materials and vehicles above U10W increased the loads in the members significantly, but the most highly loaded member (L9/U10) was estimated to be only about 5 percent above its design load. Properly designed gusset plates should still have had a significant margin of safety under these loading conditions. Also, the

increase in load arising from the construction materials and vehicles was similar to that associated with the 1977 increase in deck thickness. Thus, it was concluded that the concentrated stockpiling of construction materials and vehicles on the bridge could not be identified as the sole cause of the collapse. The increases in load over the history of the bridge were part of the circumstances that triggered the collapse, but they would not have been sufficient to cause the collapse if the main truss gusset plates had met their design requirements.

Figure 15. Loads in the five truss members connected at U10W over the history of the bridge.

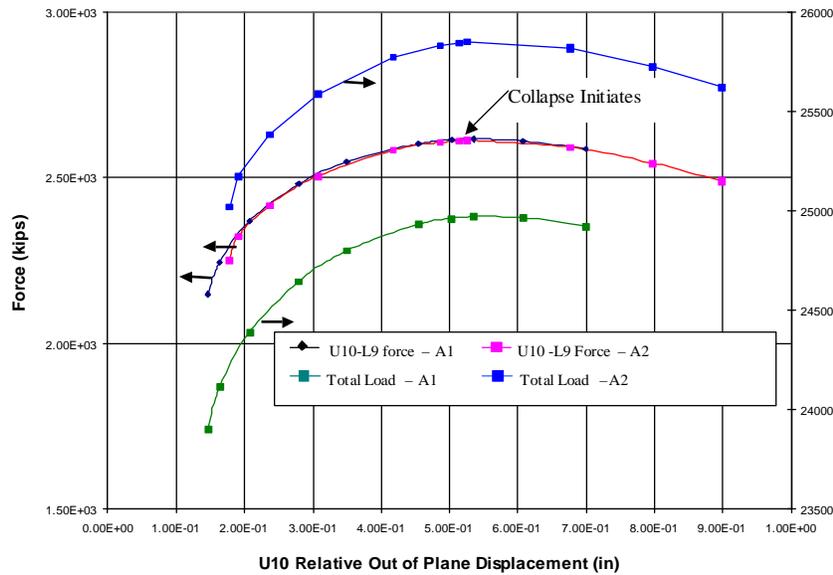
Including the photographically documented bowing distortion of the U10W gusset plates in the model reduced the load required to trigger instability and changed the direction of the deformation. With the U10W gusset plates bowed in the directions shown in the photographs, the upper

end of the L9/U10W diagonal shifts to the outside of the bridge at instability, consistent with the direction that the diagonal was observed to have shifted by the examination of the collapsed bridge structure. With initially flat U10W gusset plates in the model, the upper end of the L9/U10W diagonal shifted toward the inside of the bridge at instability, which is not consistent with the collapsed bridge structure. The source of the bowing distortion was not identified, but a relatively large initial imperfection was required to match the deformation under the loading conditions at the time when the photographs were taken. Incorporating the stress that caused the bowing would likely reduce the load necessary to trigger instability. The choice of the shape of the initial imperfection for the bowing distortion had an effect on the results.

Figure 16. L9/U10W force and total load versus out-of-plane gusset plate displacement for failure cases A1 and A2. At failure, the L9/U10W force and gusset plate displacement are the same for both cases.
