Failure Analysis of World Trade Center 5

Summary

On September 11, 2001, flaming debris from the World Trade Center tower collapse ignited fires in World Trade Center 5. These fires burned unchecked and caused a localized collapse from the 8th floor to the 4th floor in the eastern section of the building.

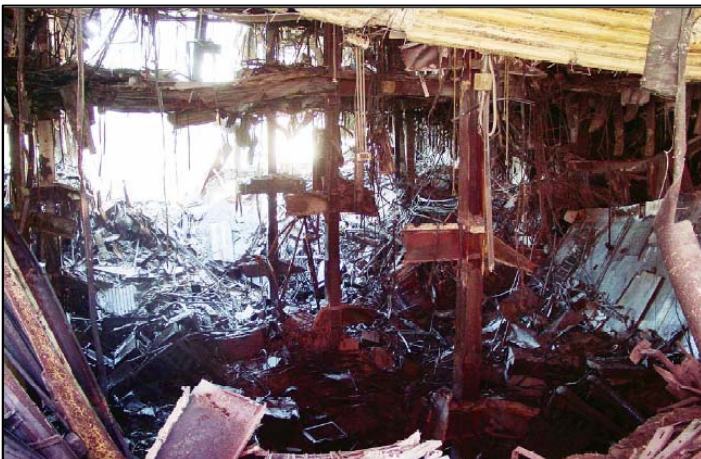
Figure 1: Internal collapse area in WTC 5 [1]

World Trade Center 5 (WTC 5) was a nine-story building located in New York City, NY. On September 11, 2001, due to uncontrolled fires, the eastern portion of WTC 5 experienced an internal progressive collapse. Structural impact was not a factor in this failure; the collapse was caused by fire alone. A portion of the collapsed area is shown in Figure 1.

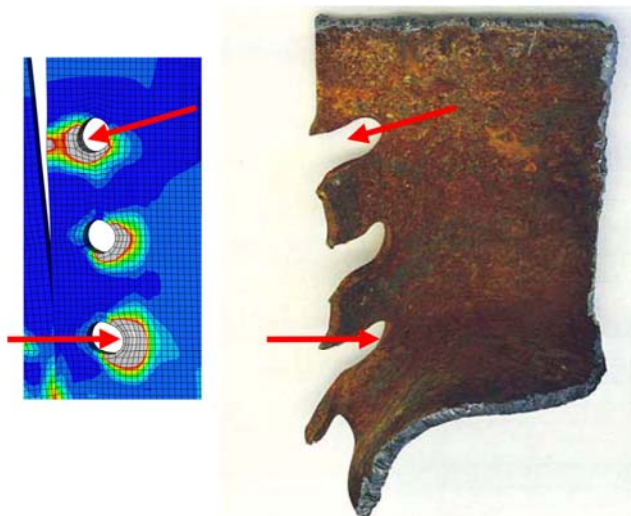
Figure 6: Comparison of Abaqus model results and forensic evidence

It was observed that the deformation in the Abaqus model is very similar to that of a collected structural specimen from WTC 5 that underwent failure. More precisely, the angles at which the bolts pried against the bolt holes are similar in the model and the specimen, as shown in Figure 6. Moreover, photographs of failed beam stems show evidence of fulcrum point deformations.

The shear connection failures in WTC 5 were due to shear rupture of the web portion of the beam stems. This type of failure occurs when the bolts bear against the weak side (i.e., acting toward the free end of the member) of the bolt holes. Bearing stress of this type causes shear planes to form in the web steel. Finally, cracks along the shear planes cause catastrophic failure of the shear connection.
