Minneapolis I-35W Bridge Collapse – Engineering Evaluations and Finite Element Analyses

Carl R. Schultheisz, Alan S. Kushner
National Transportation Safety Board

Abstract: The National Transportation Safety Board (NTSB) investigates accidents to identify the probable cause and to make recommendations that would prevent similar accidents. Following the collapse of the I-35W bridge in Minneapolis on August 1, 2007, the NTSB worked with the Federal Highway Administration, the Minnesota Department of Transportation and other parties with information and expertise, including SIMULIA Central, to determine the circumstances that contributed to the collapse of the bridge, completing the investigation in 15 months. The NTSB concluded that the collapse of the bridge was caused by the inadequate load capacity of gusset plates used to connect the truss members, as a result of an error by the bridge design firm, Sverdrup & Parcel and Associates, Inc. The loading conditions included a combination of (1) substantial increases in the weight of the bridge caused by previous bridge modifications, and (2) the traffic and concentrated construction loads on the bridge on the day of the collapse. Evid

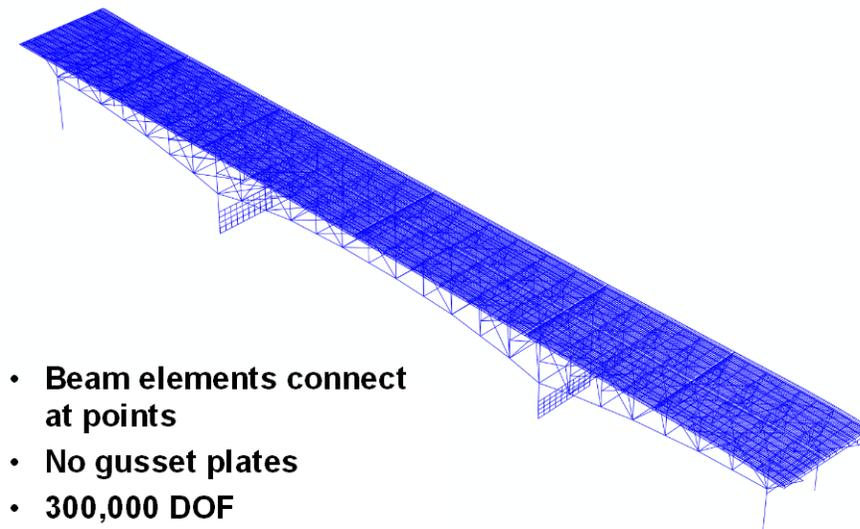
The models were based on the original Sverdrup & Parcel design plans and the Allied Structural Steel shop drawings. The FHWA developed a three-dimensional global model of the entire deck truss portion of the bridge, constructed with beam and shell elements. See Figure 8. In addition, both the FHWA and SUNY/SIMULIA created detailed models of the U10 and L11 nodes to examine the fine details of stress distribution. These detailed models were built into the FHWA global model of the bridge. See Figure 9. The FHWA detailed model generally used shell-element representations for the truss members and the gusset plates, while the SUNY/SIMULIA detailed models used solid-element representations; the solid-element approach was in part motivated by a goal of considering stress concentrations associated with the riveted connections.

Figure 8. The FHWA global model consisting of beam and shell elements.

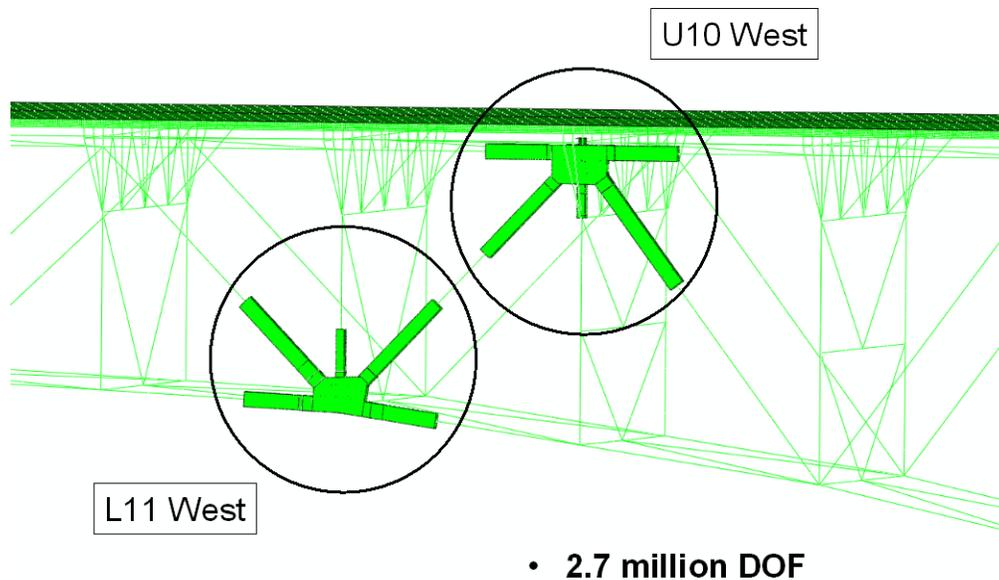
Figure 9. U10W and L11W detailed models built into the FHWA global model.
